### E-ISOLATION

## Full-scale dynamic testing machine, getting precise force-deformation relationships during the test without friction or inertia forces.

Japan Seismic Isolation Laboratory

### Our long-desired, high-performance, real-scale test machine started in Japan.

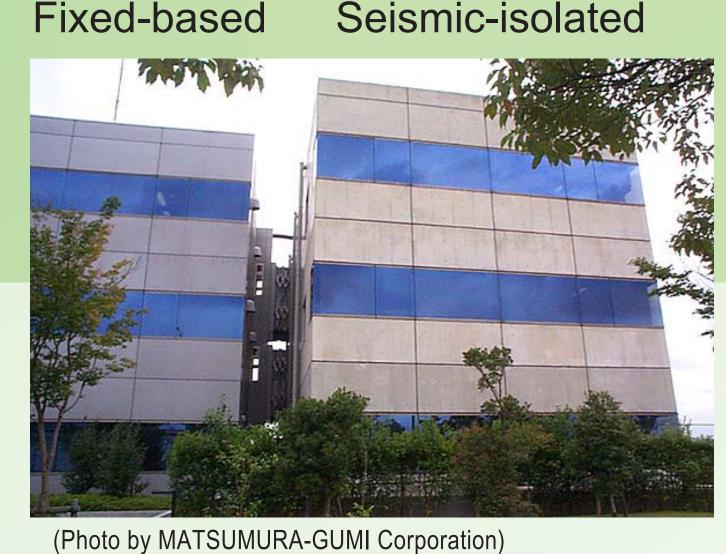
Seismic isolation layers and devices

Building	Location	Direction	
		NS	EW
Seismic-isolated	Roof	198	273
	1st	148	253
Fixed-based	Roof	965	677
Foundation		272	213

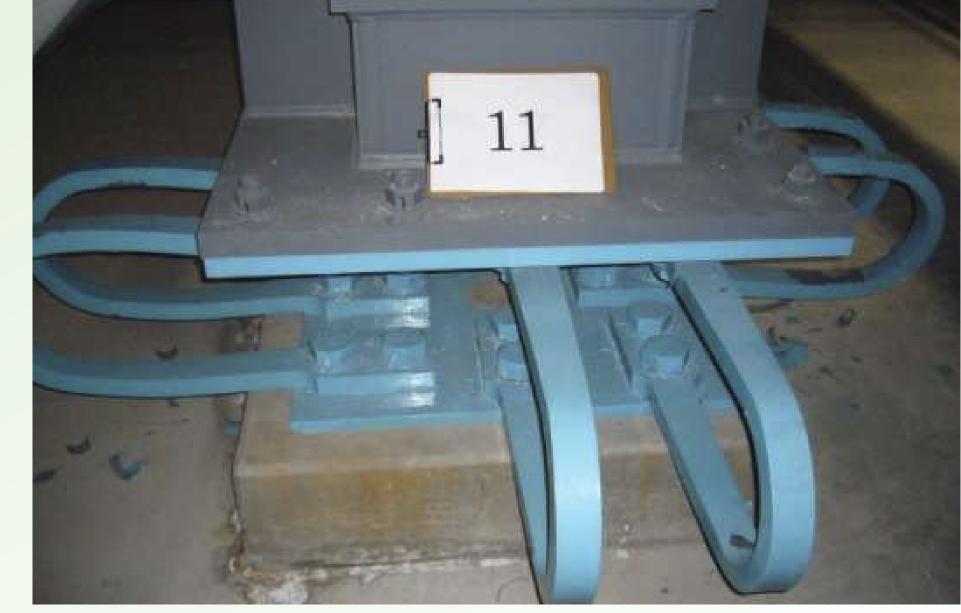
▲ Many ductile steel dampers dissipated earthquake energy

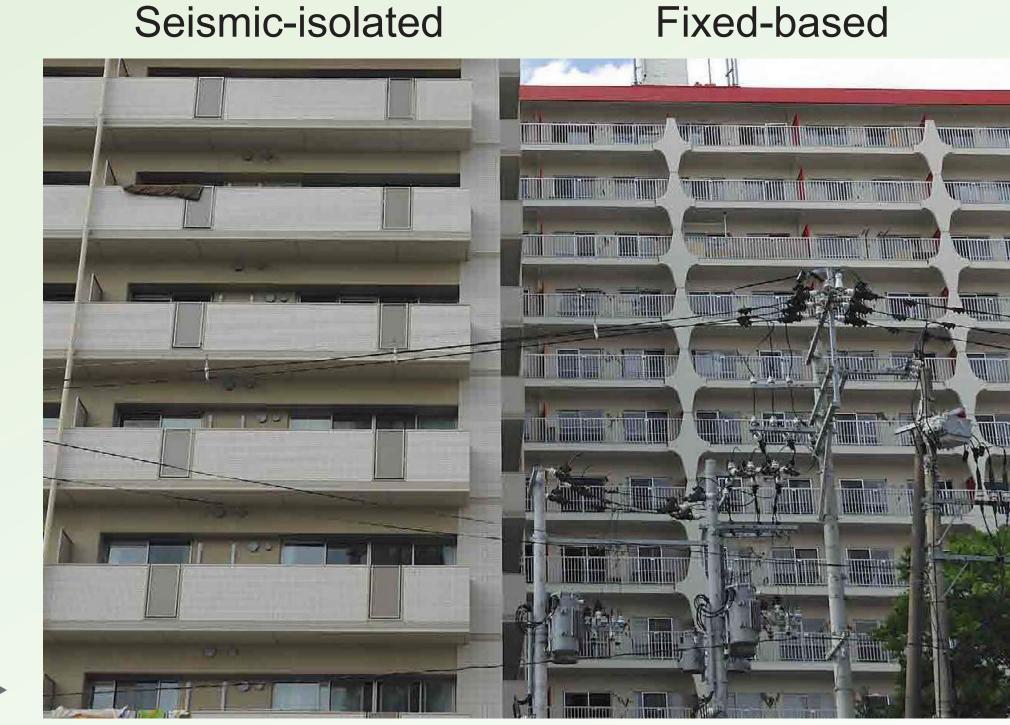
- There were two apartment buildings adjacent to each other in Sendai city.
- One was a seismic-isolated building, and the other was a fixed-based one.
- The seismic-isolated apartment sustained no damage and people were able to live just after the earthquake.
- The fixed-based apartment protected people's lives, but the building tilted and many cracks appeared in the walls and columns.
- The fixed-based apartment was demolished because people did not want to return to the damaged rooms.

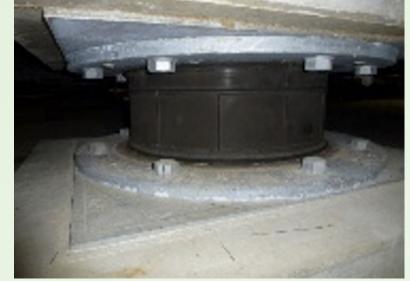
Natural rubber bearing and LRB were used.
The bearings remained intact even after 46cm deformation (shear strain of 330%)

- The maximum displacement of the seismic isolation layer was recorded at 46cm.
- The building's functions were maintained without any problems even immediately after the earthquake, so the facility was able to be active as a base of operations for disaster relief teams.
