Our long-desired, high-performance, real-scale test machine started in Japan.

# The Japan Society of Seismic Isolation & Japan Seismic Isolation Laboratory

## Seismic Isolated vs Fix-Based in 30 Years in Japan

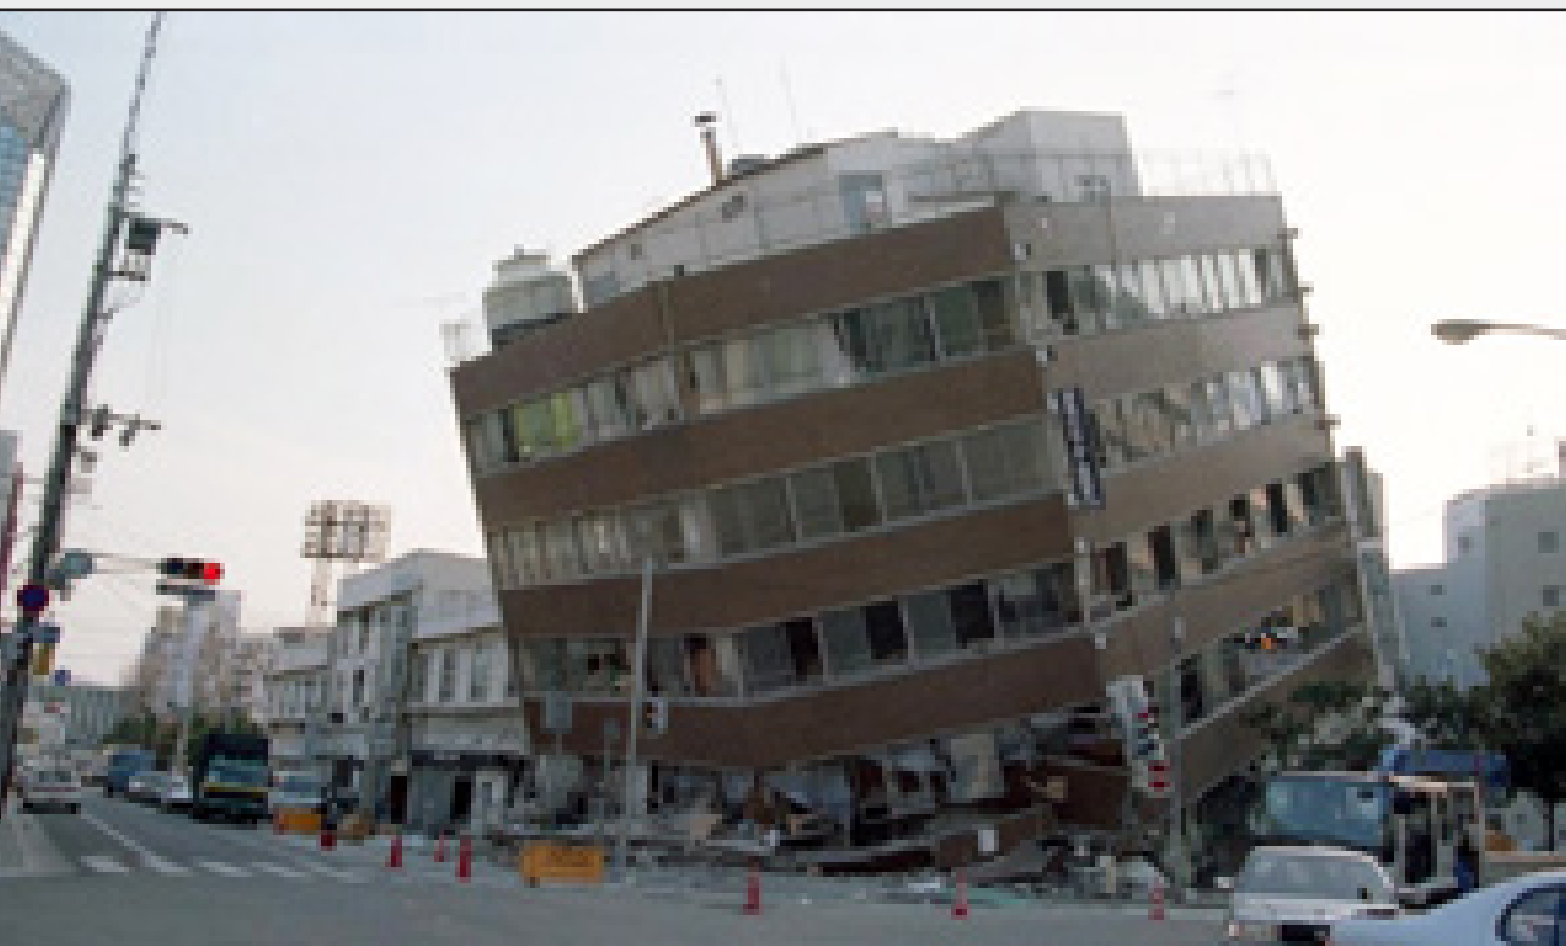
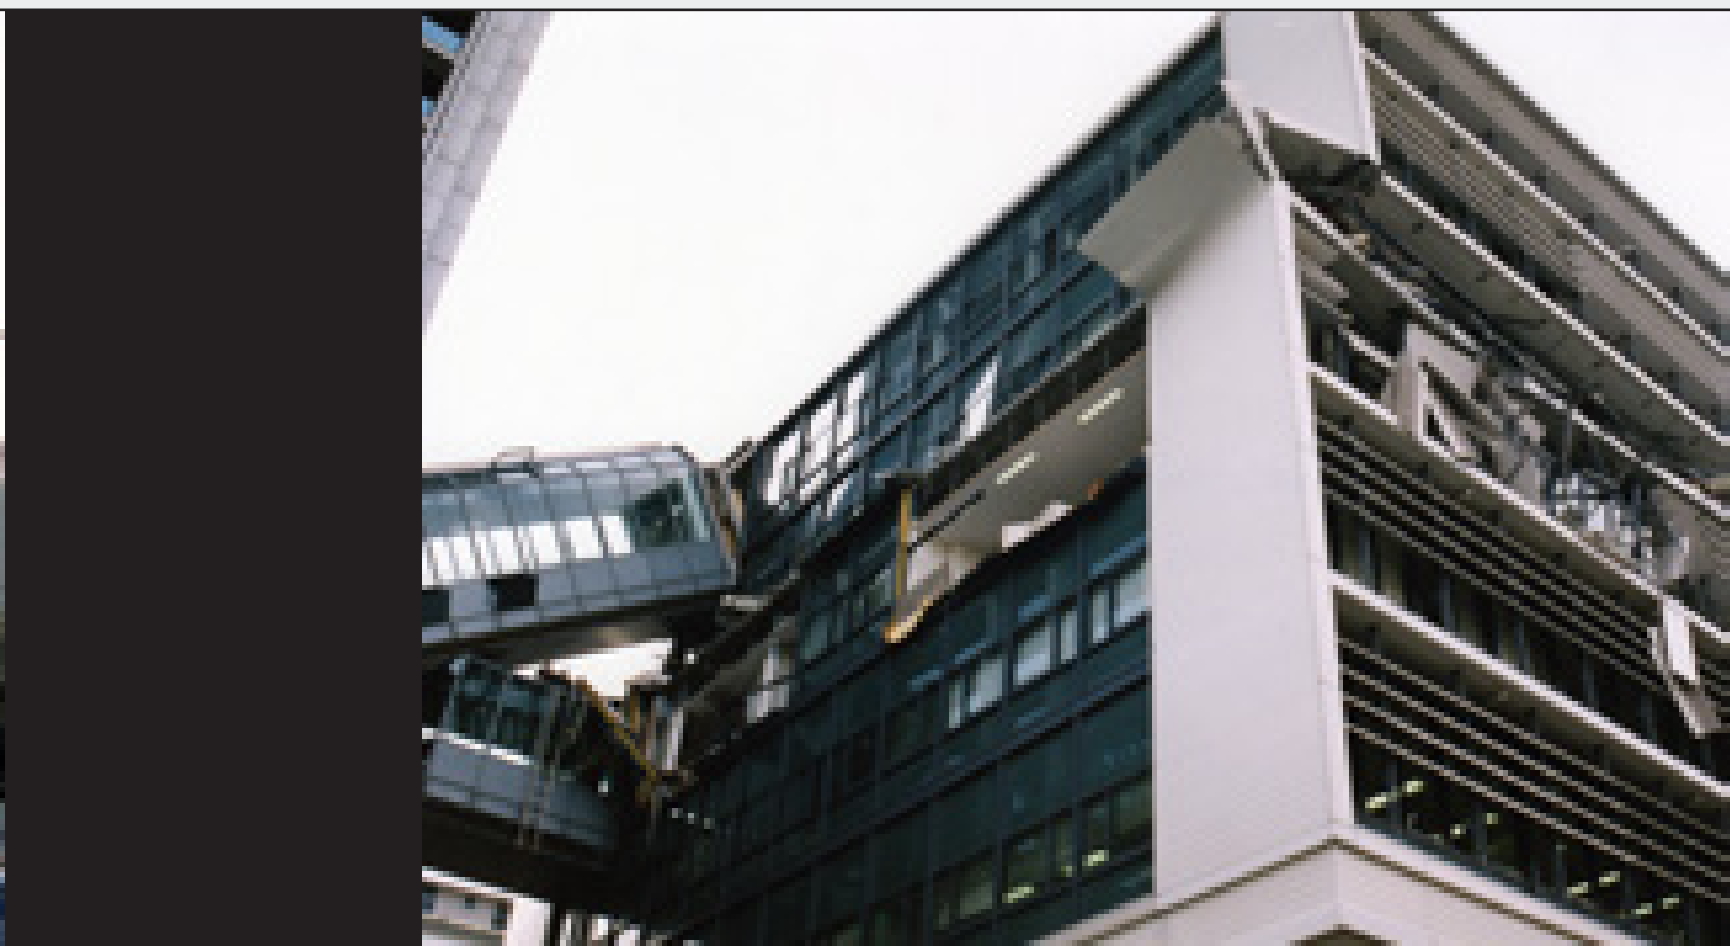
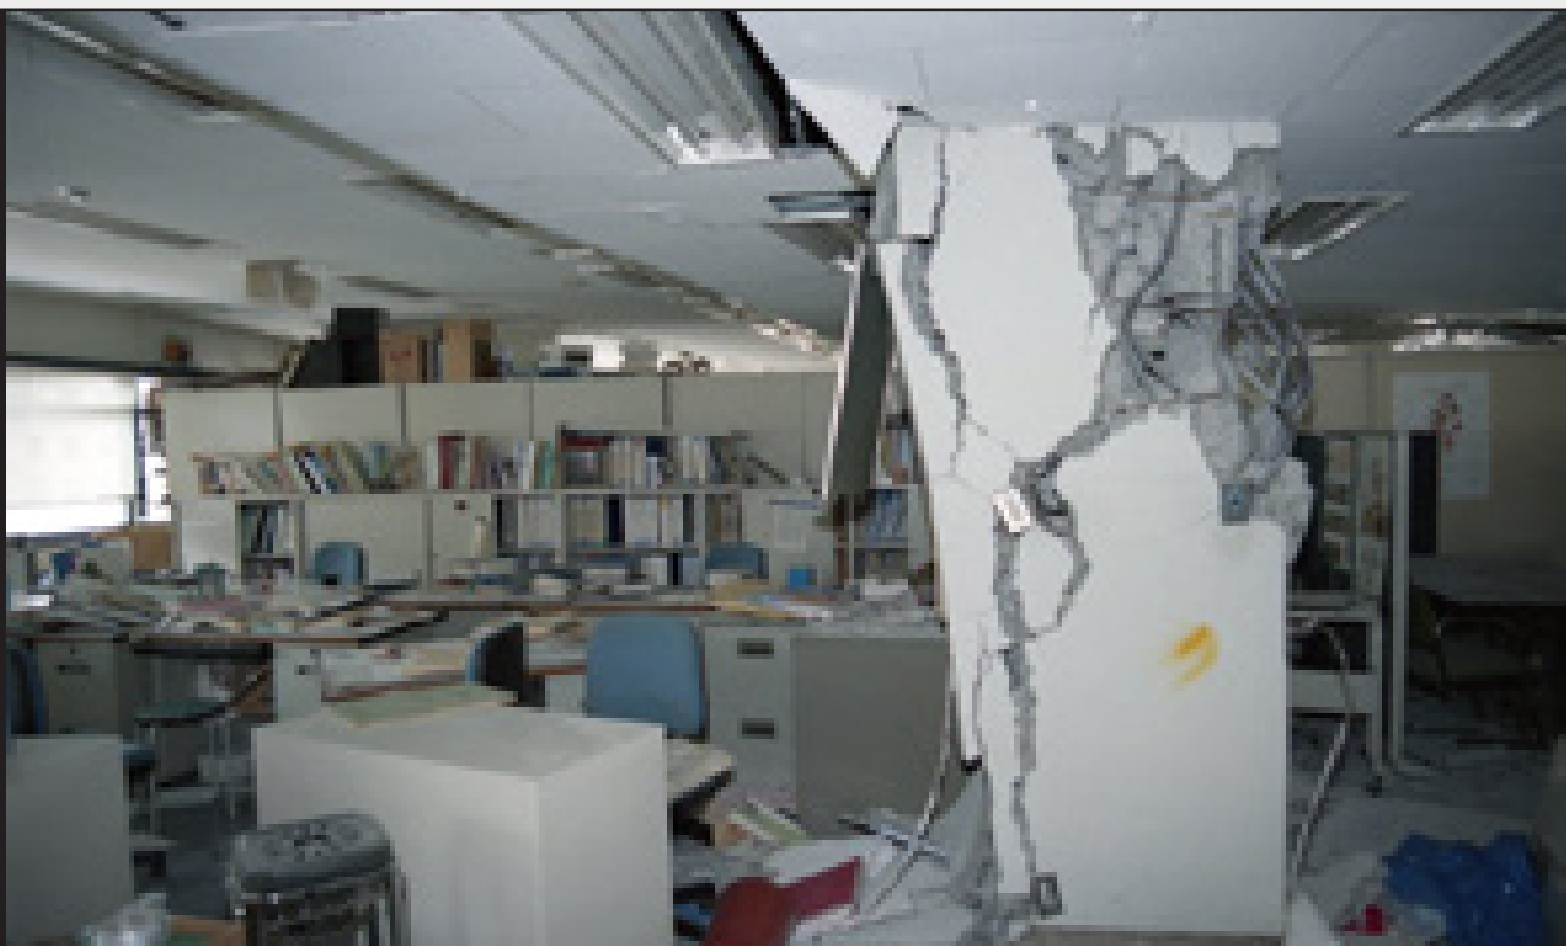
(Photo by Kobe City)

Many houses, buildings and infrastructures had been destroyed in Kobe

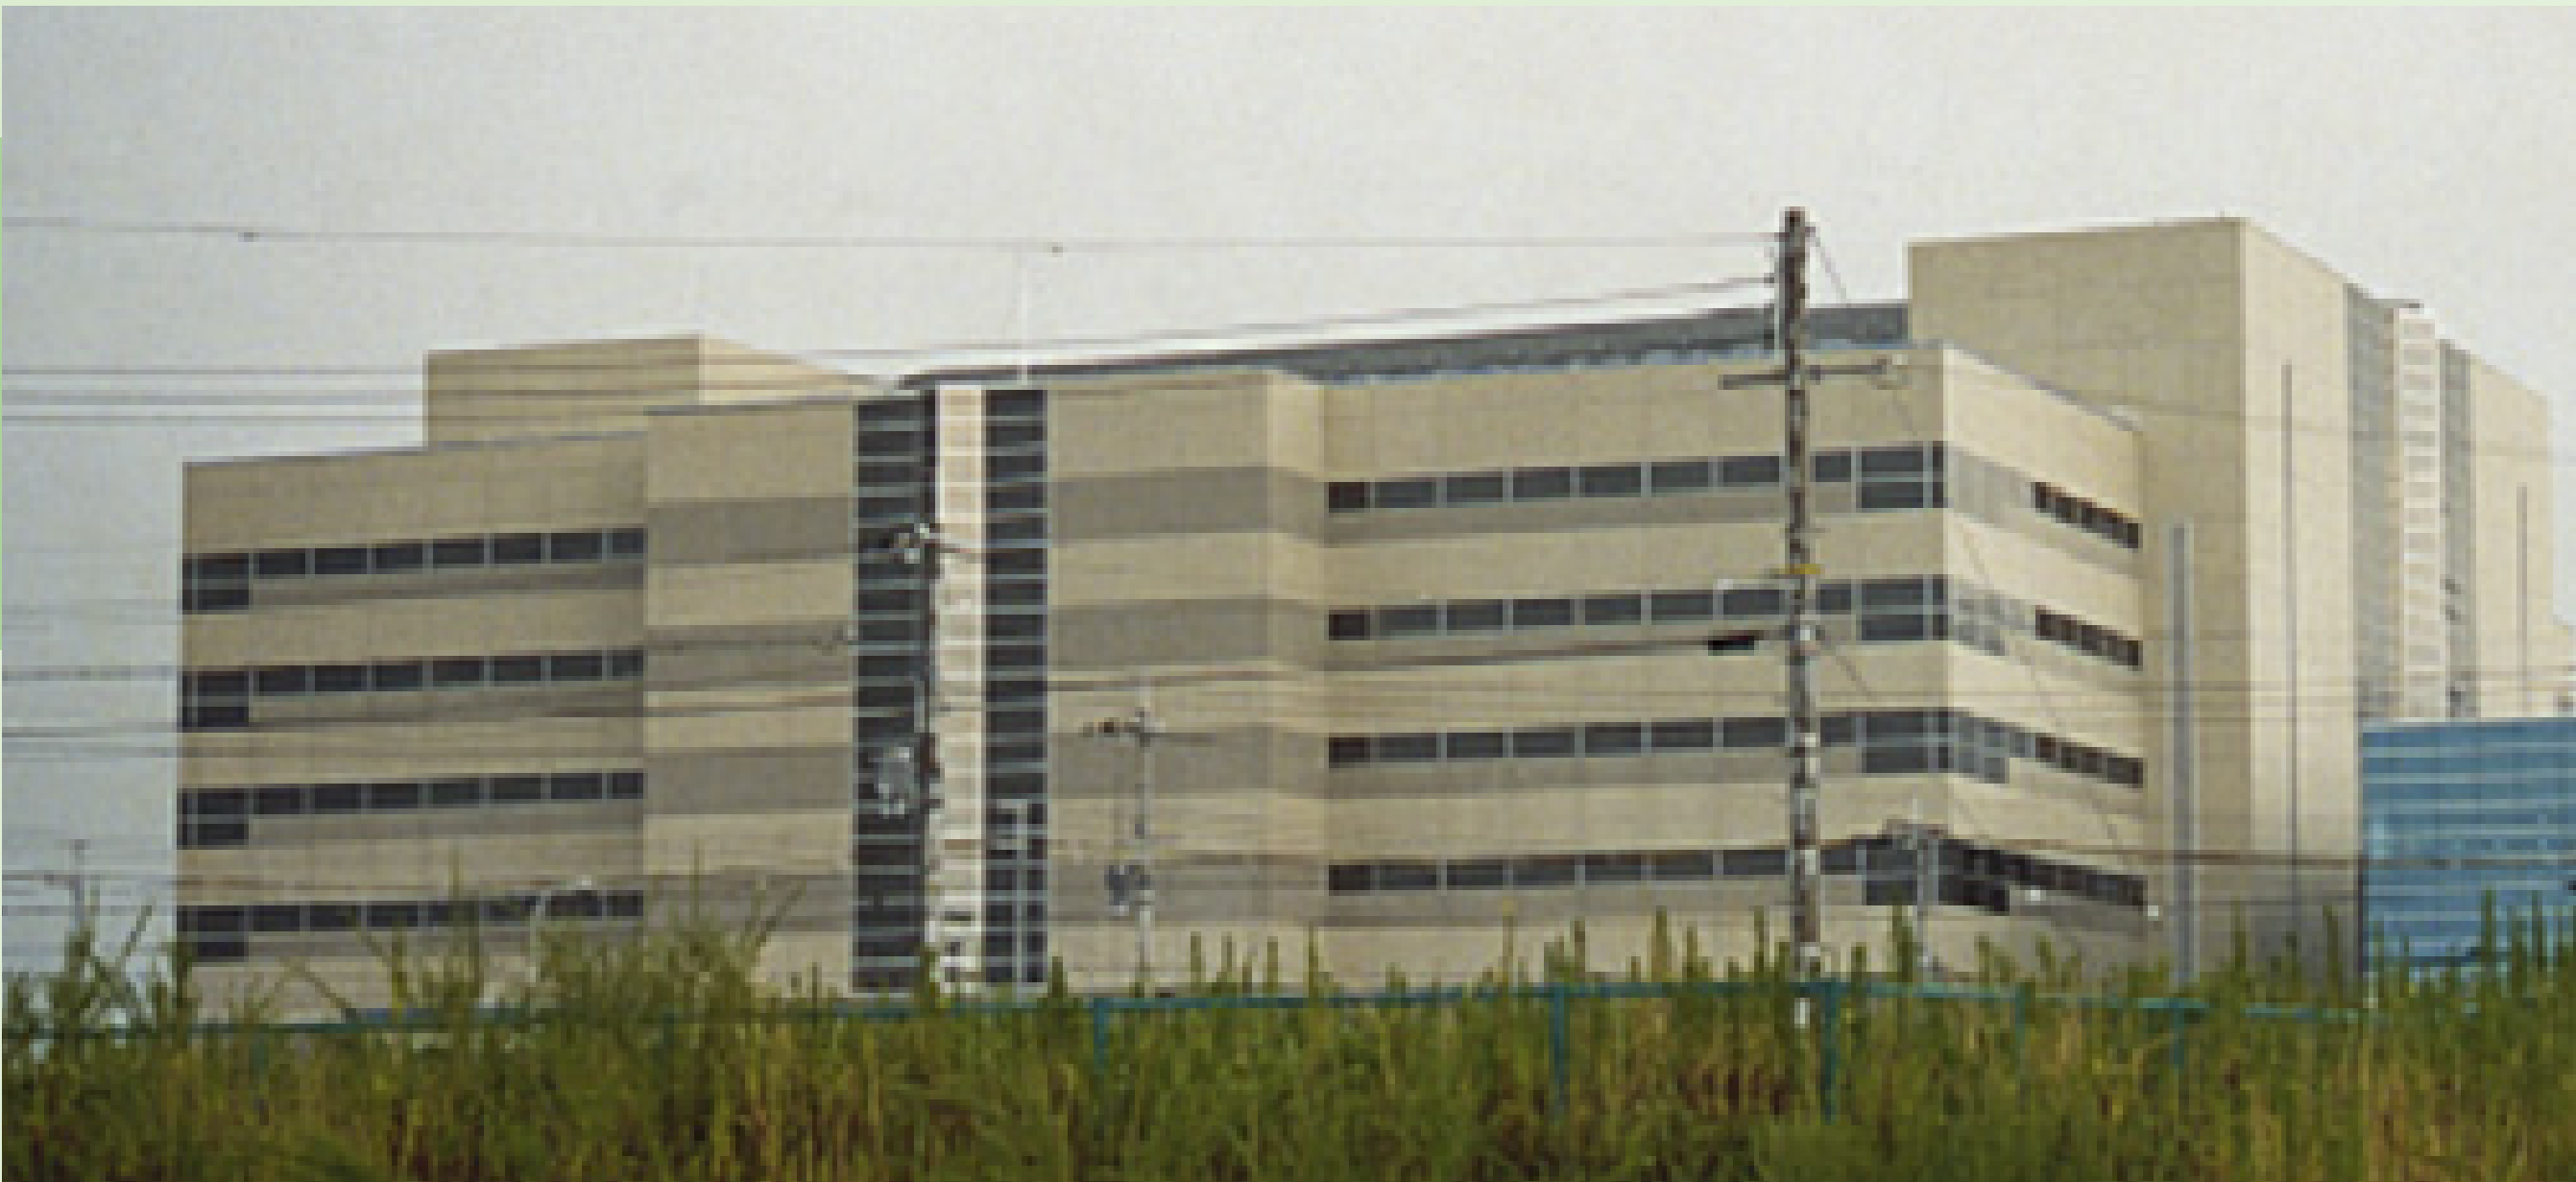
#### WEST Building

There were only two seismic-isolated buildings in Kobe city in 1995.  
Both isolated buildings performed very well.

The acceleration above the seismic-isolated layer was reduced to about 30% of the acceleration at the foundation.

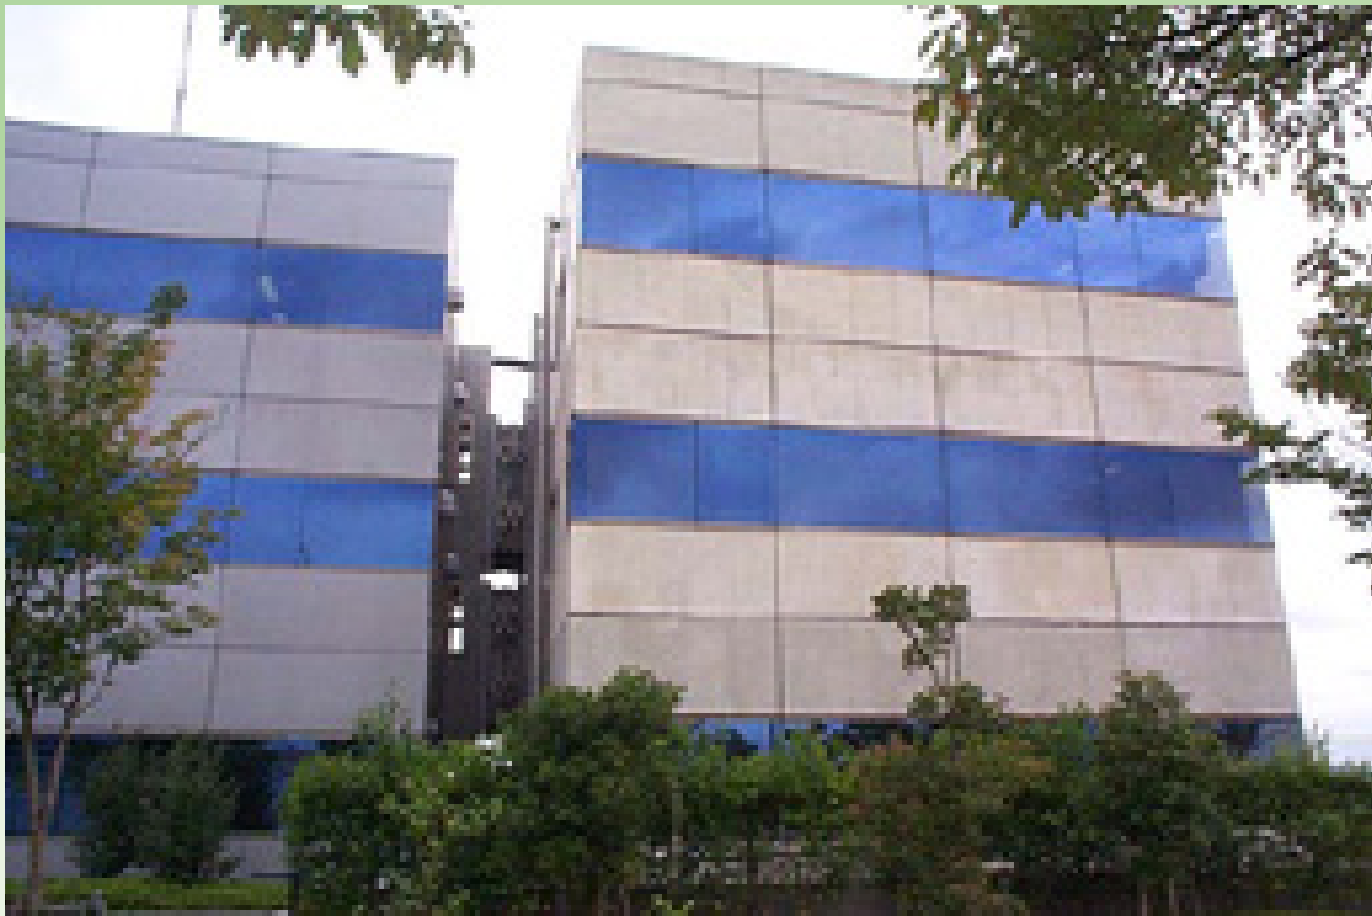
#### Matsumura-Gumi Technical Research Institute

Fixed-based Seismic-isolated

The Matsumura-Gumi construction built two buildings of the same shape in its research center, one of which was fixed-based and the other was seismic-isolated, to collect vibration data under an earthquake.

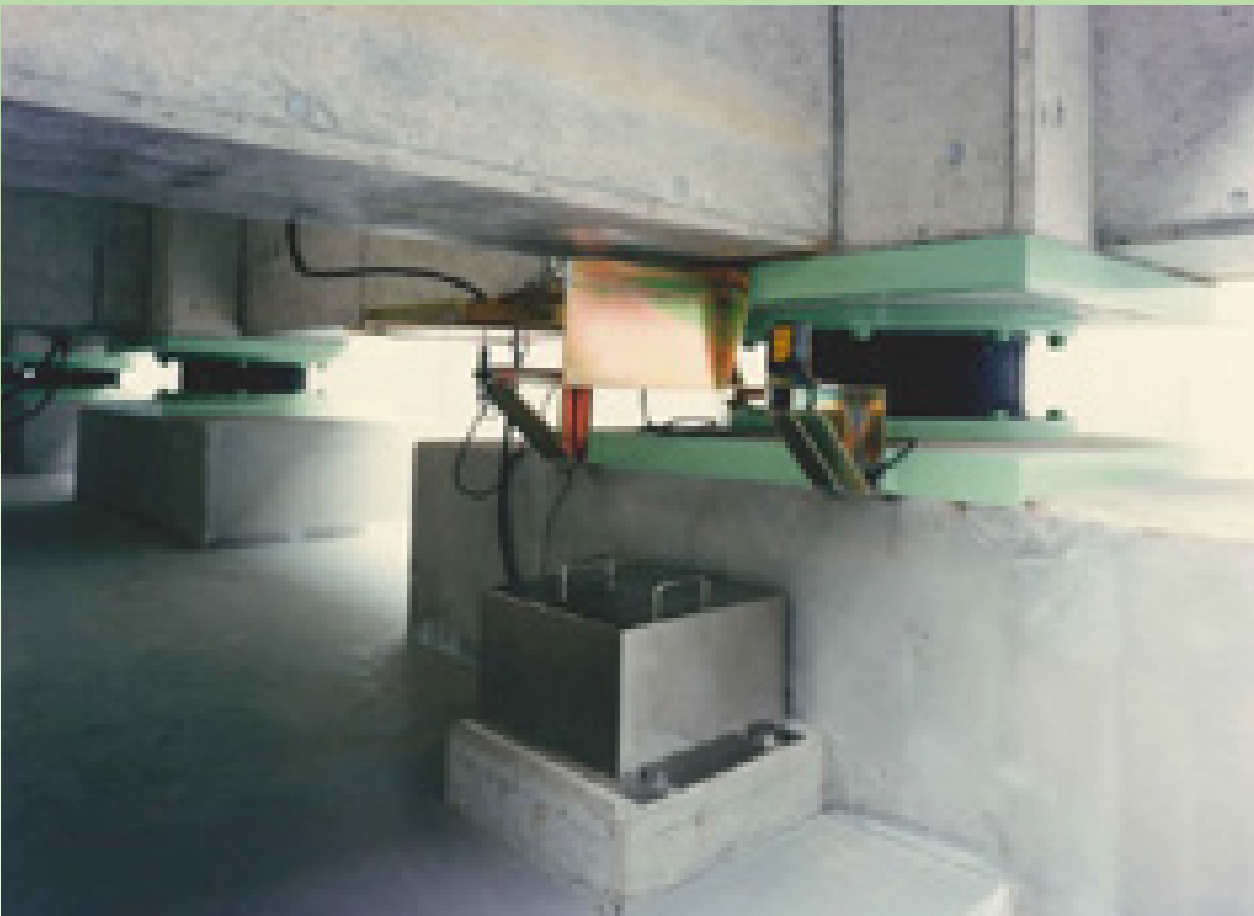
▲ Seismic isolation layers and devices

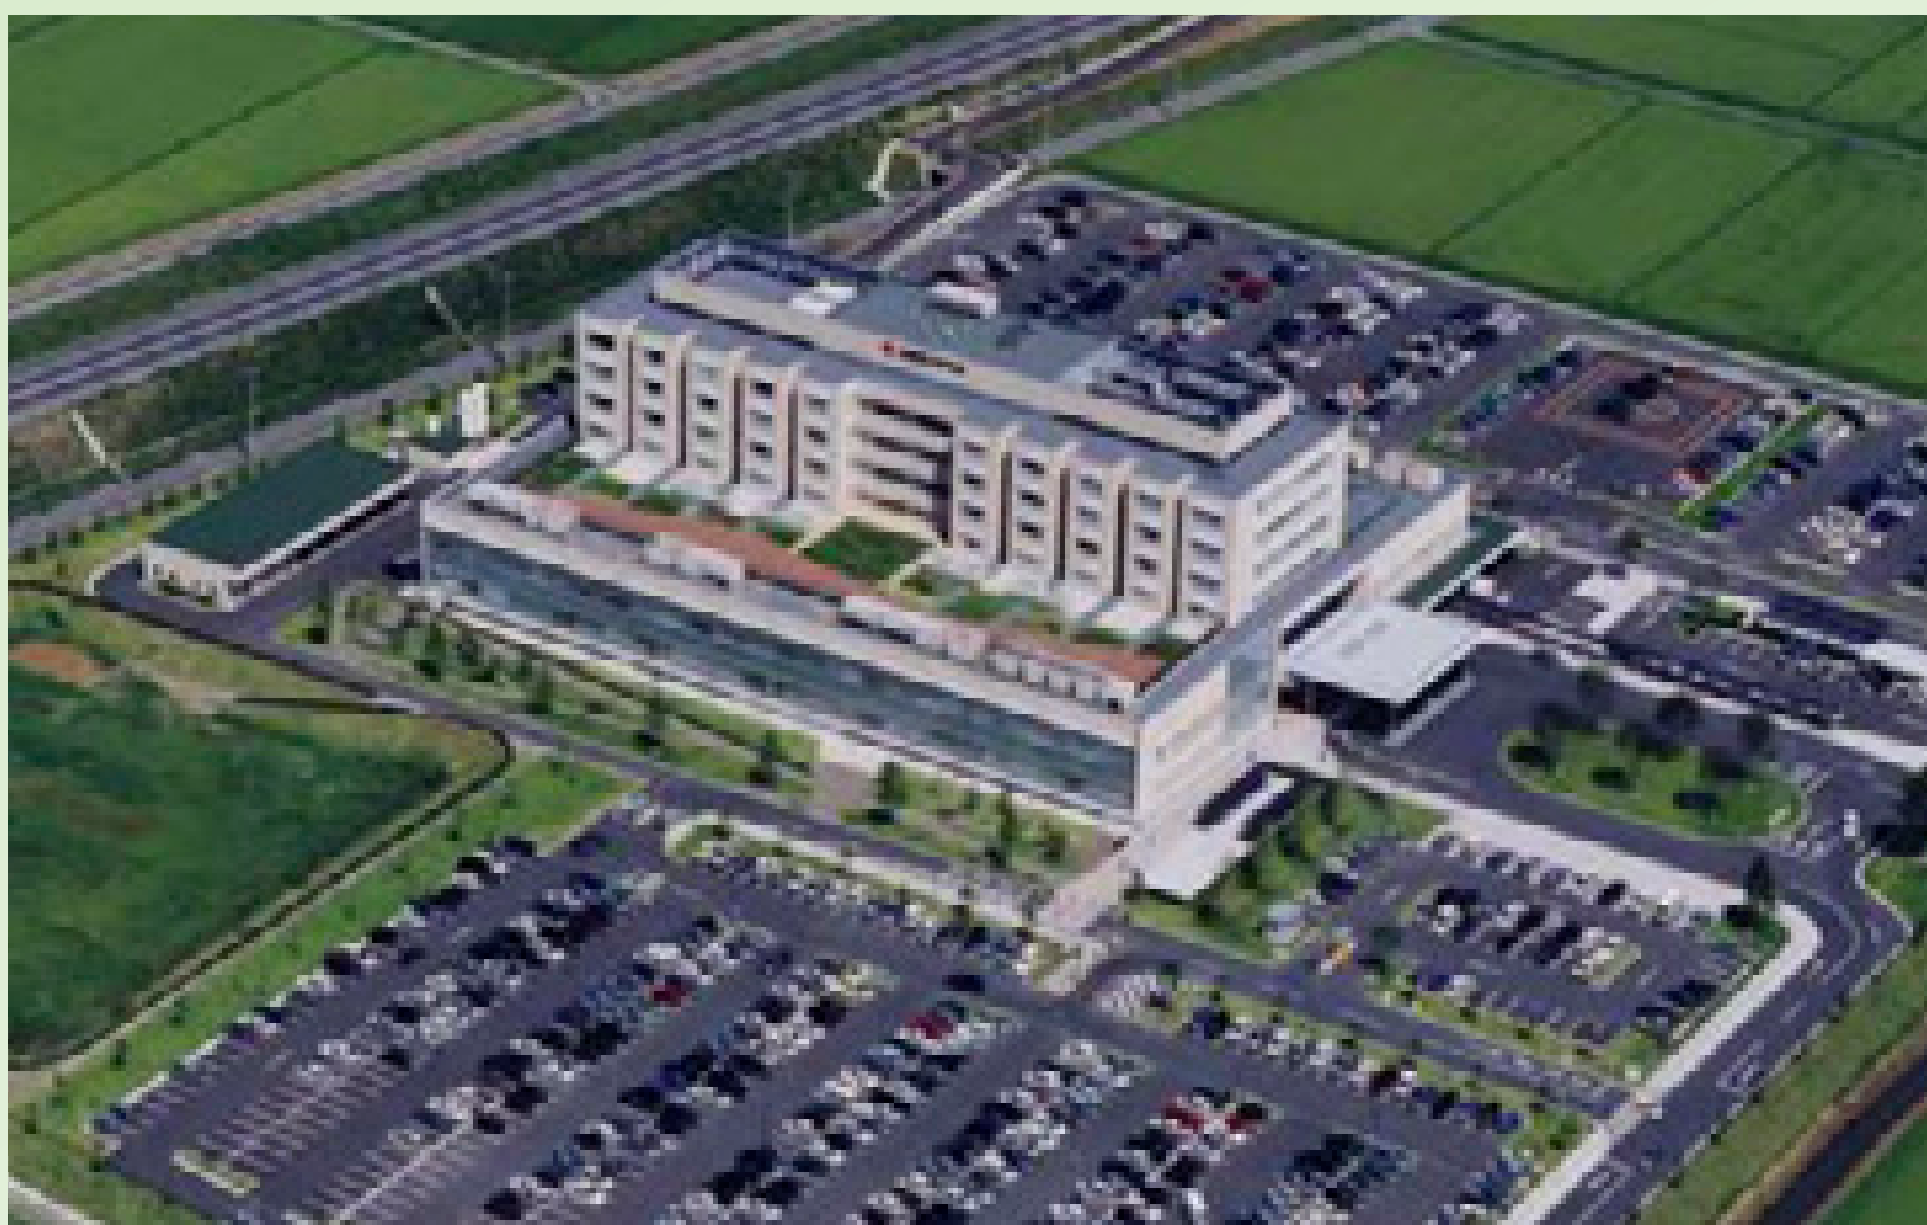
(Photo by Japanese Red Cross Ishinomaki Hospital)

### The Ishinomaki Red Cross seismic-isolated hospital maintained its functions perfectly even after the earthquake and served as a disaster base hospital for the region.

- The seismic-isolated hospital was able to continue providing medical care as a local disaster base hospital.
- The first-floor entrance hall had been planned as a space for treatment in the event of the disaster.
- The steel dampers dissipated huge earthquake energy and still active against the next earthquakes.

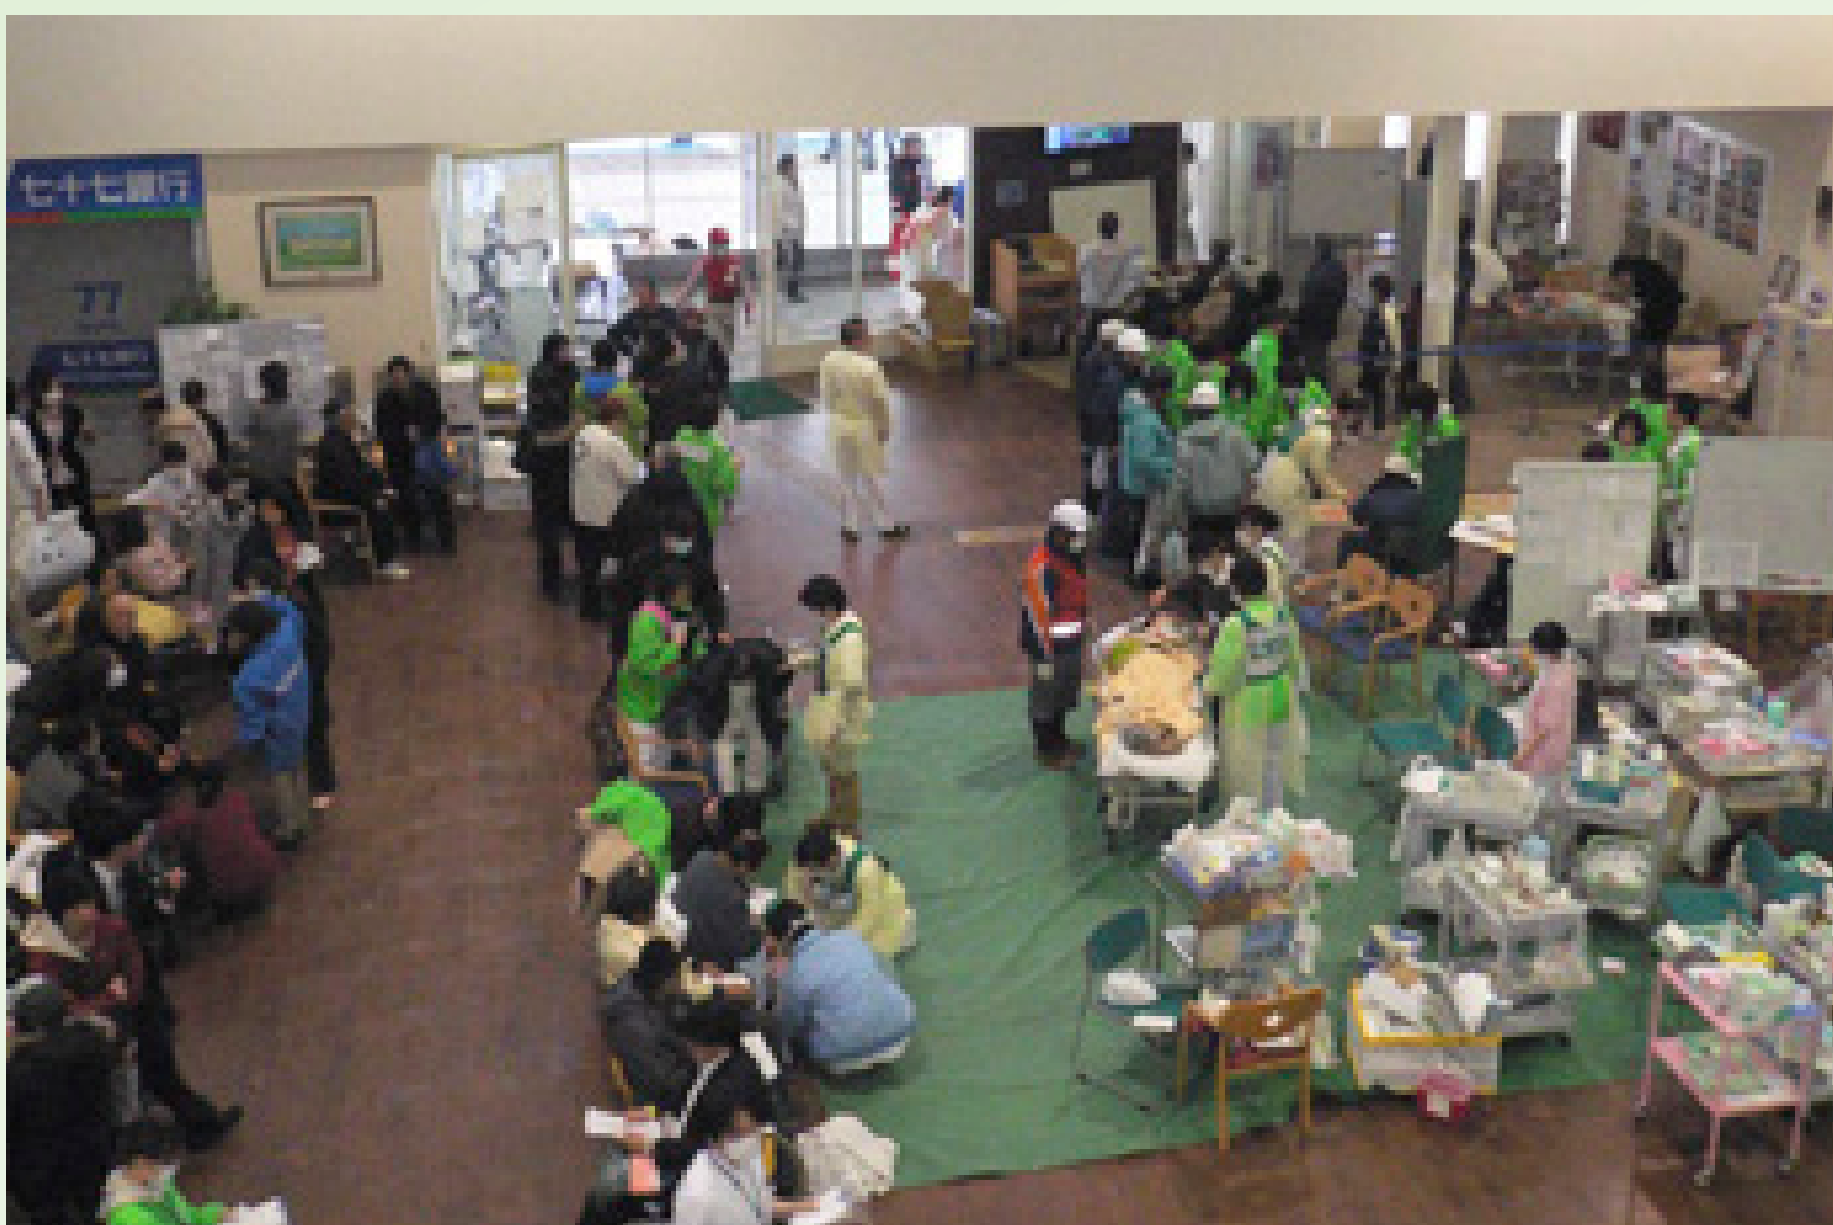
▲ Entrance hall situation immediately after the earthquake

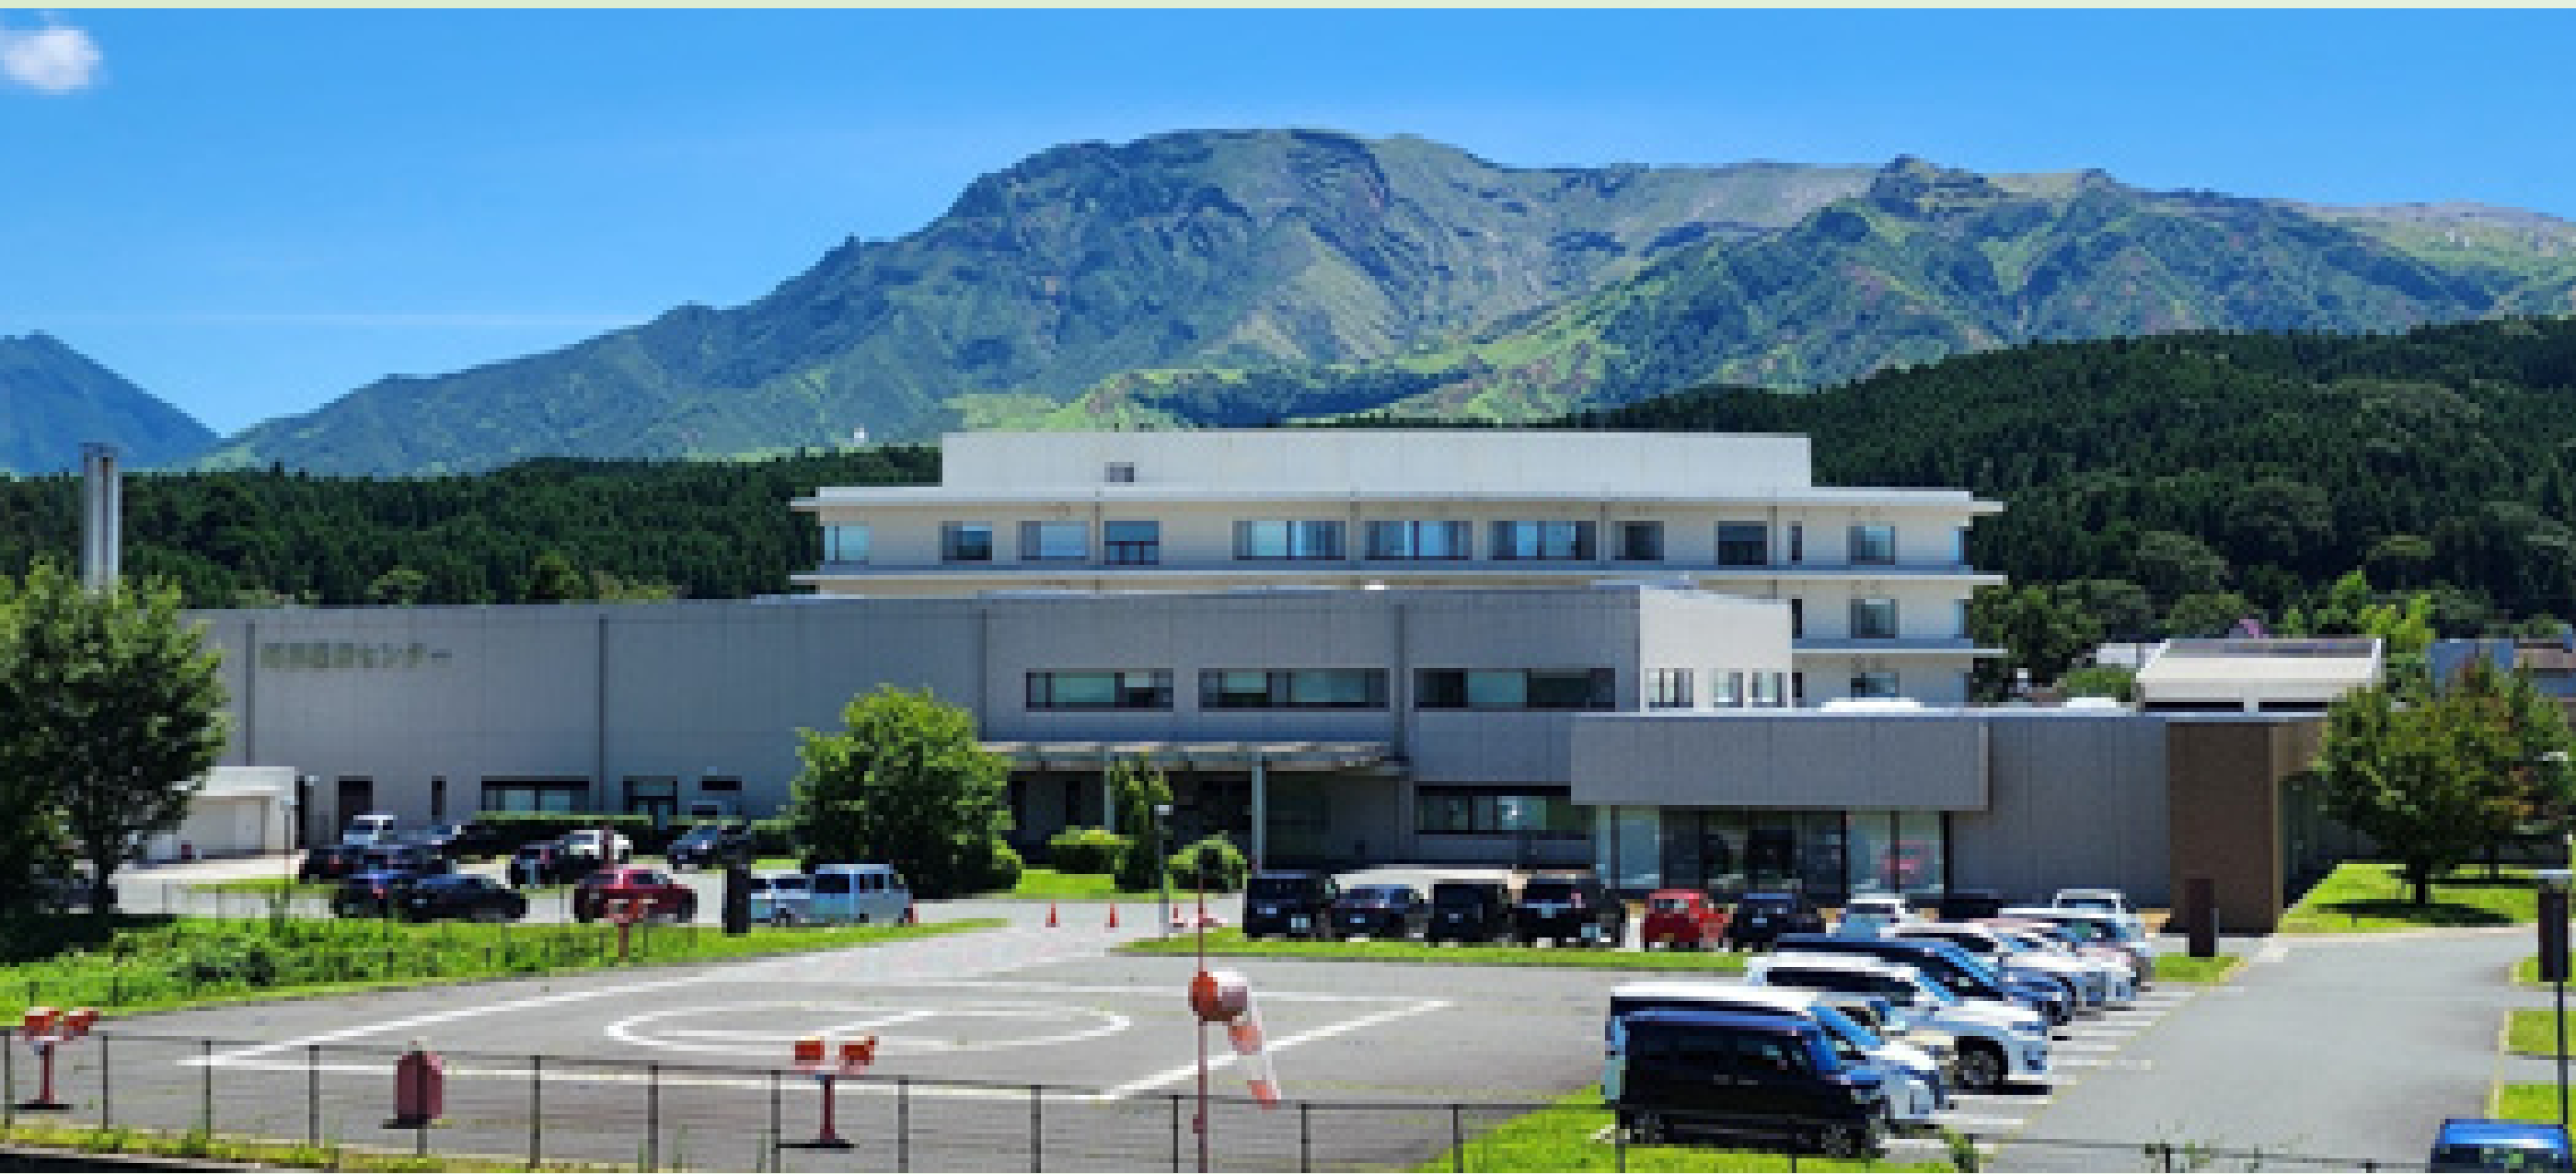
(Photo by Aso Medical Center)

### Seismic-isolated hospital kept the functions. (Aso medical center)

- The maximum displacement of the seismic isolation layer was recorded at 46cm.
- The building's functions were maintained without any problems even immediately after the earthquake, so the facility was able to be active as a base of operations for disaster relief teams.

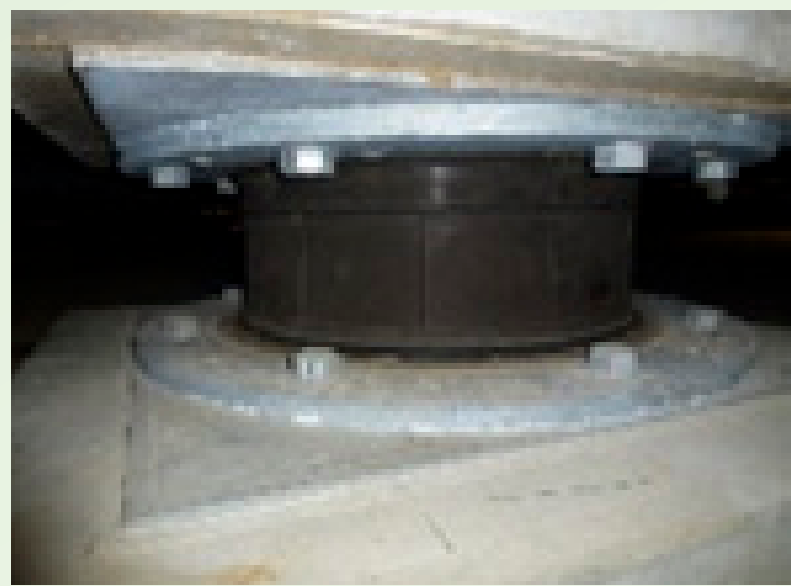
Natural rubber bearing and LRB were used. The bearings remained intact even after 46cm deformation (shear strain of 330%)

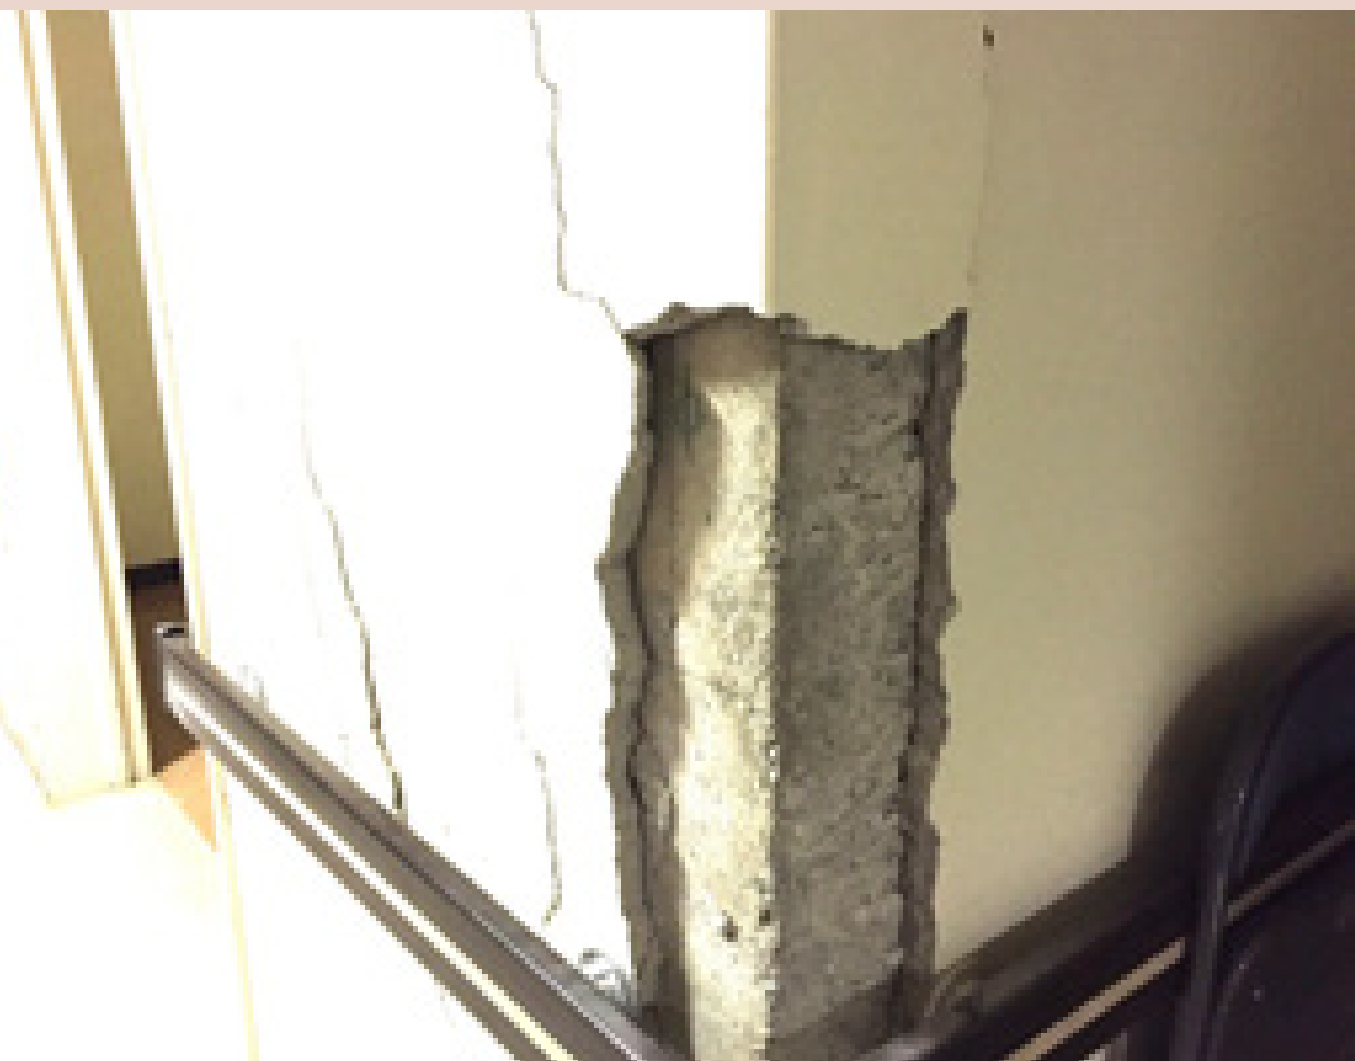
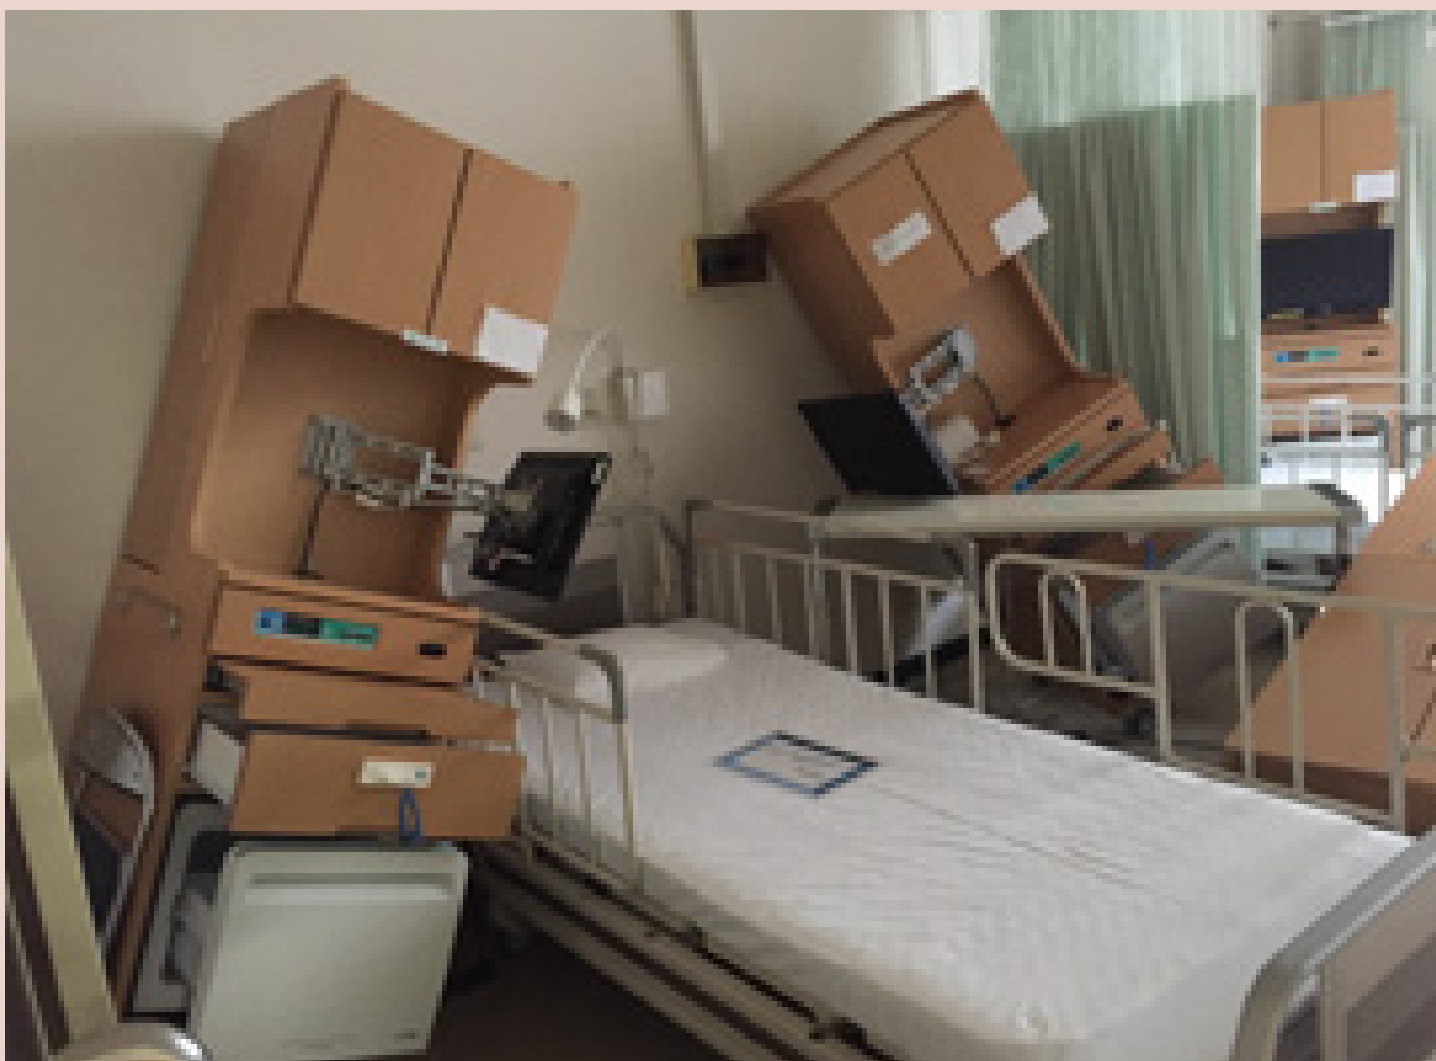
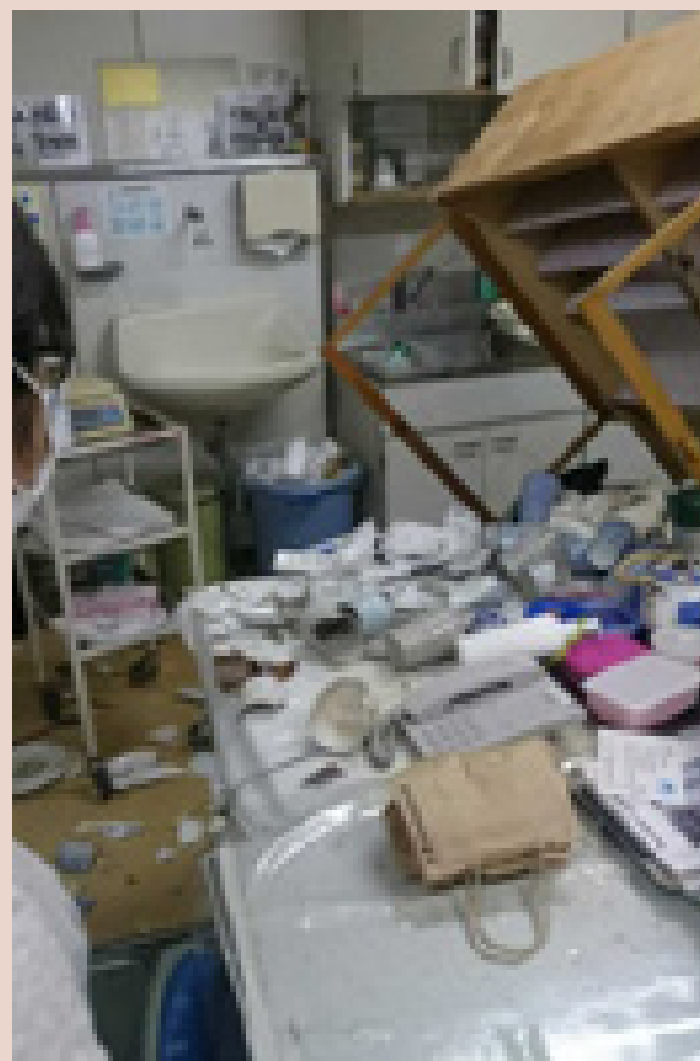
The Kumamoto City Hospital, which had a fixed-based building, suffered significant damage to the building. Furniture and equipment also fell over, making it impossible to continue medical care, so 320 patients were transferred to other hospitals. After that, the building was demolished and a new hospital with a seismic-isolated structure was built.

The hospital suffered significant damage, and lost its hospital functions.  
It was demolished and rebuilt using a seismic-isolate structure.
