Our long-desired, high-performance, real-scale test machine started in Japan.

# The Japan Society of Seismic Isolation & Japan Seismic Isolation Laboratory

## Seismic Isolated vs Fix-Based in 30 Years in Japan

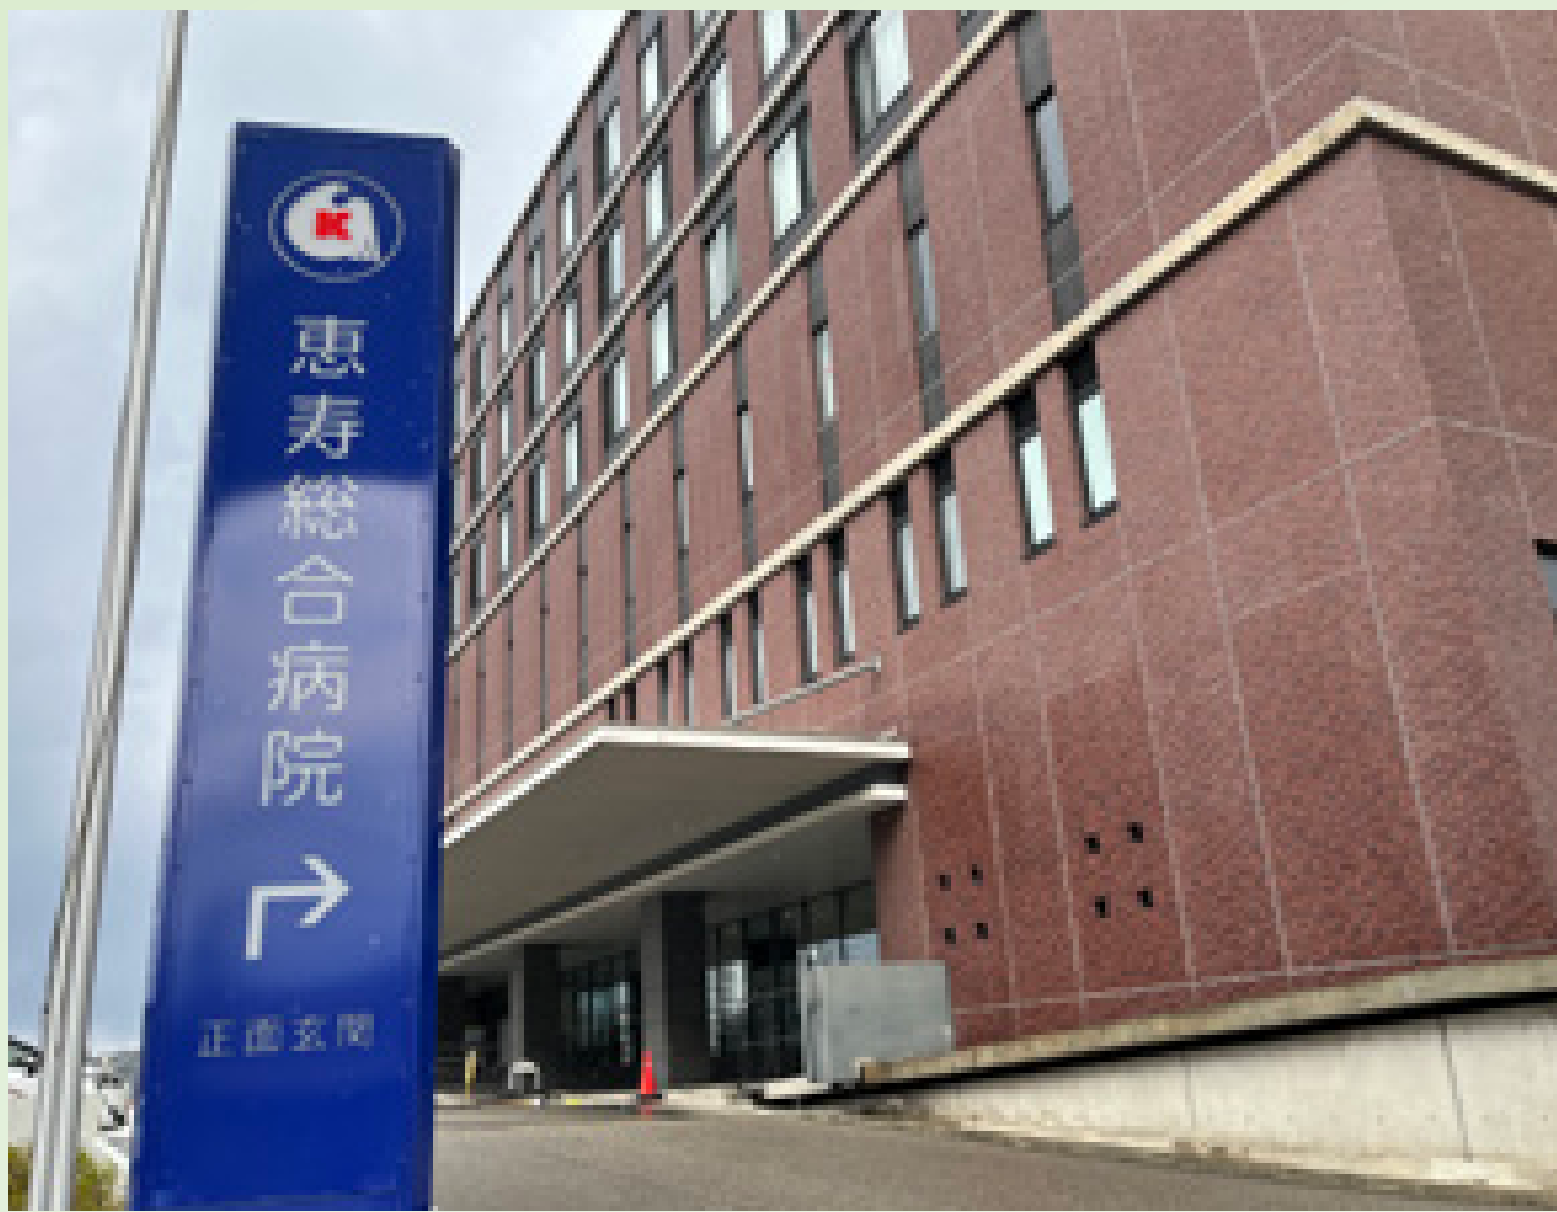
▲ Appearance after the quake

- The earthquake intensity was a lower 6. The maximum displacement of the seismic isolation layer was recorded at about 19cm.
- The building was all right, and no medical equipment or furniture was toppled. The operating room was also completely all right, active medical care to continue.

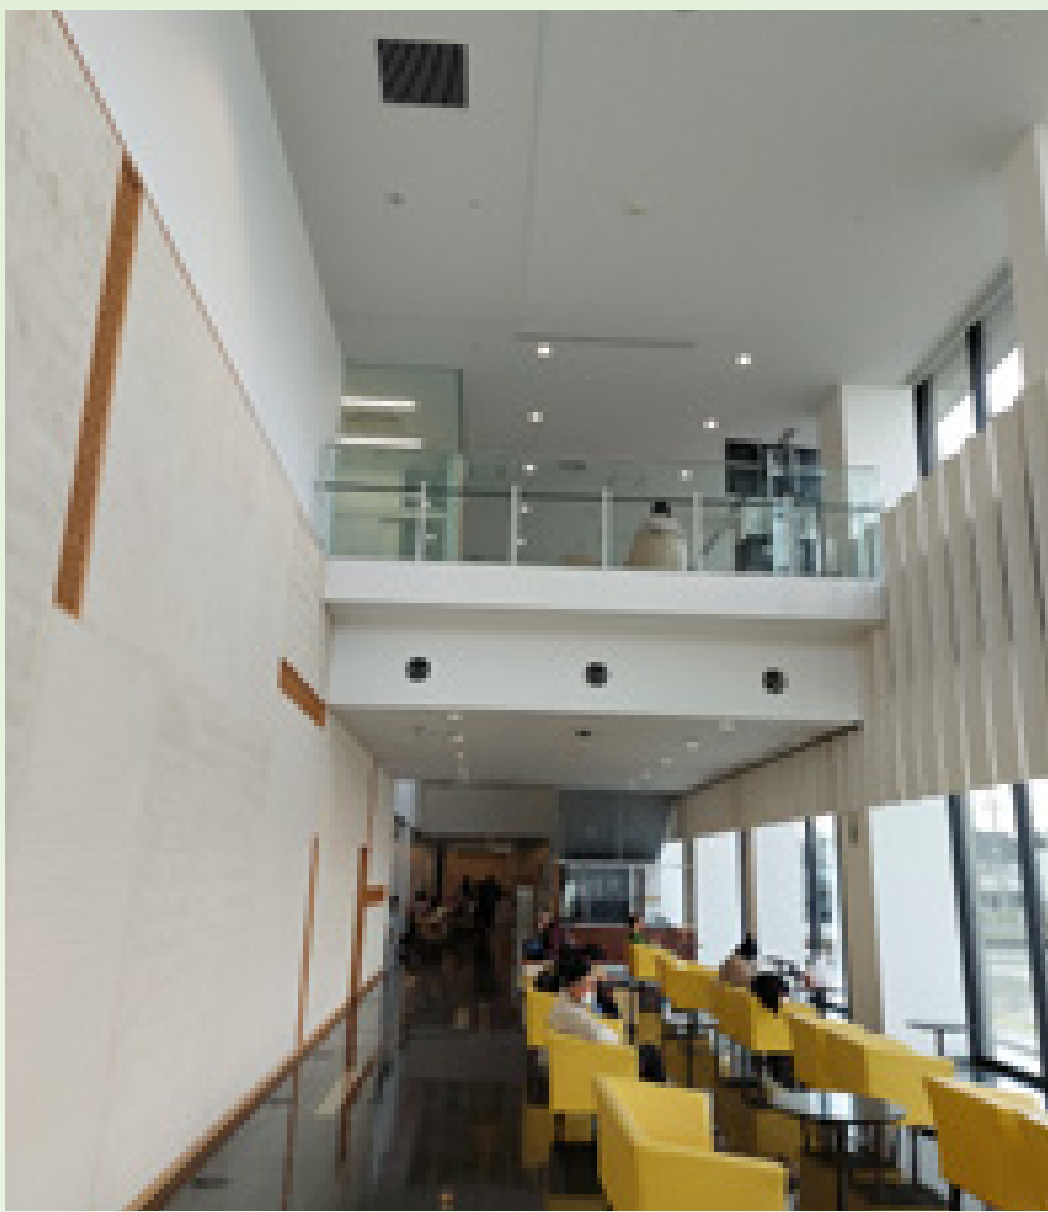
▲ Internal situation after the quake

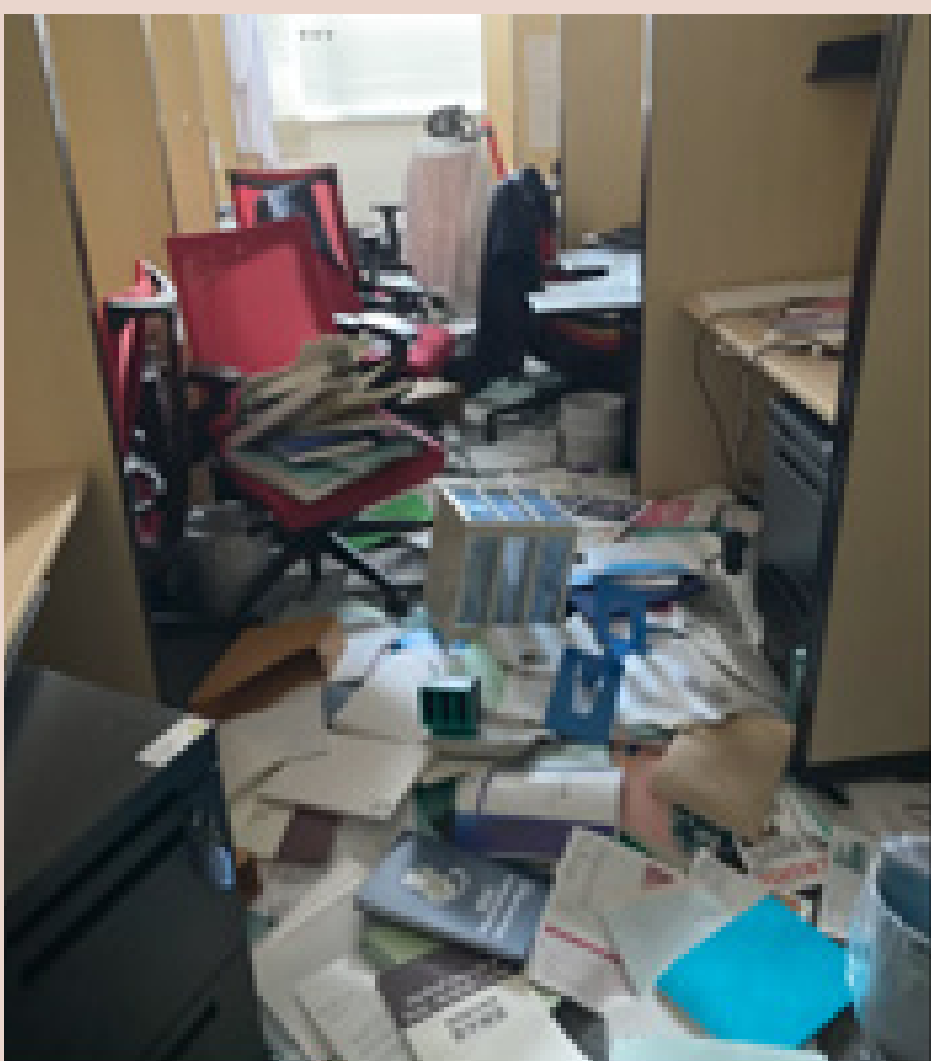
No structural damage to the building, but medical equipment, furniture, and facilities had fallen over and were damaged, became impossible for the hospital to continue functioning.
